2020/01/27 FRONTIER Task 3 Workshop @ ORNL

Corrosion experiment DURING electron irradiation performed by KURRI-LINAC

Masafumi Akiyoshi

Radiation Research Center, Osaka Prefecture University

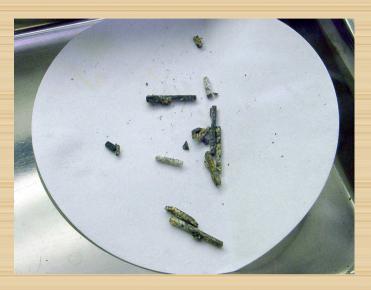
In 2003, ceramics specimens irradiated by japanese experimental fast-reactor JOYO using CMIR-5 rig were extracted from their capsules. Two capsules were filled with white infiltrate that showed strong acid. It was considered Na was infiltrated to the capsules. All ceramic materials (α -Al₂O₃, AlN, β -Si₃N₄ and β -SiC) were stable in liquid Na without irradiation, but these specimens showed severe damage. β -Si₃N₄ and β -SiC showed good shape but showed large swelling (up to 10%), and furthermore, α -Al₂O₃ and AlN were disrupted into small pieces.

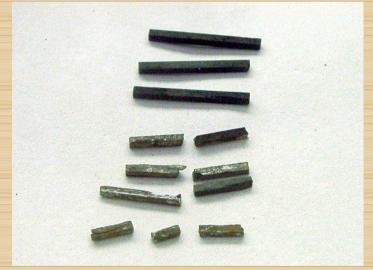
T66 capsule $8.0 \times 10^{26} \text{ n/m}^2 \text{ (fast) at } 677^{\circ}\text{C}$

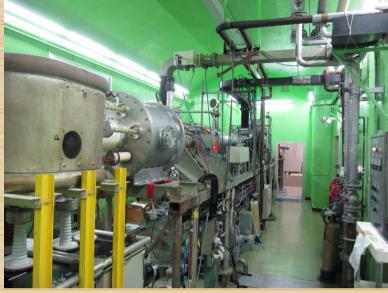
30MeV Electron Accelerator

KURRI-LINAC

Accelerate Energy: 28-32MeV The beam current: ~230 μ A

Peak current of pulse: ∼600mA

Pulse width: 4 µ s

Pulse frequency: ∼100Hz

Energy Flux: ~7kW in several cm

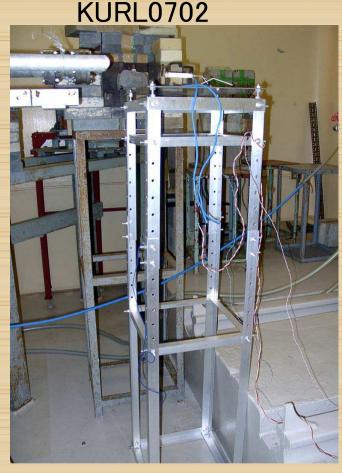
Temperature Control:
Beam Frequency
+ Kanthal heater

KURL0602: 1095°C

Quartz Glass tube and alumina cement, kanthal heater 30MeV, 3μ s x 500mA x 30Hz (1.35kW)

KURL0702: 700°C

Alumina tube and alumina cement, kanthal heater 30MeV, 3μ s x 530mA x 12Hz (0.57kW)

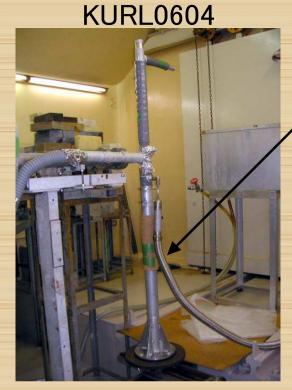
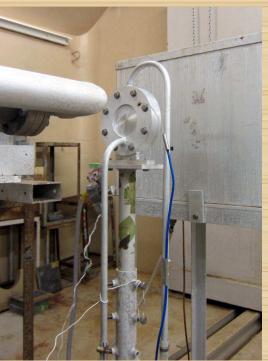
KURL0604: -165° C / 1.35kW Liquid Nitrogen cooled system 30MeV, 3 μ s x 500mA x 30Hz

Liquid Nitrogen Supply

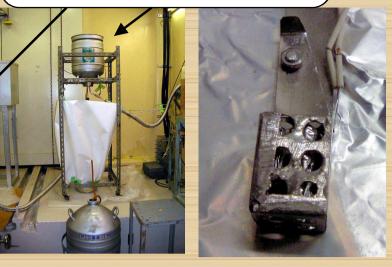
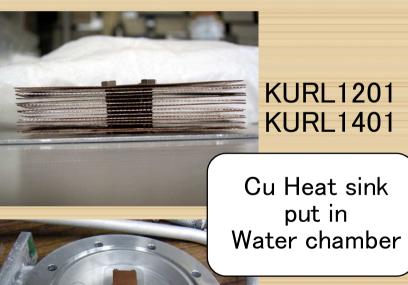
Cu heat sink in Water chamber

KURL1201: 80° C / 6.0kW 32MeV, 4μ s x 590mA x 80Hz

KURL1401: 90° C / 4.7kW 28MeV, 4μ s x 600mA x 70Hz

Very Stable and Established Irradiation System

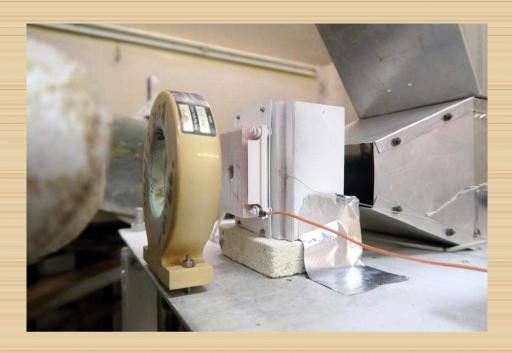
KURL1801 First attempt for Liquid-metal corrosion test

CT monitor and pre heat sink was burn!

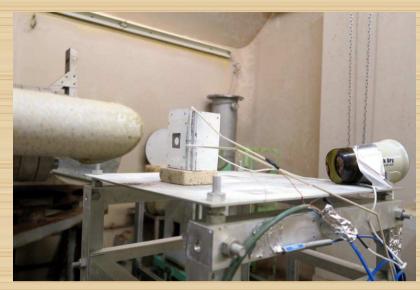
KURL1801 Second attempt for Liquid-metal corrosion test

Beam time: 2.4×10^5 sec (66.7h)

Dose: 1.1×10^{20} e, 4.4 mdpa (for Fe E_d =40keV)

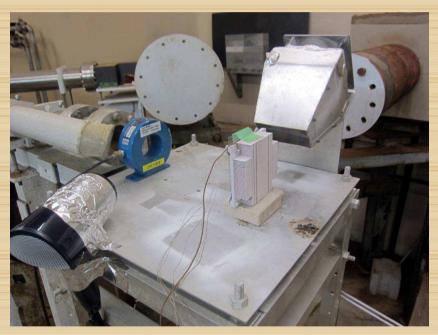
KURL1901 Third attempt for Liquid-metal corrosion test

1st specimen (NTK04L, pre oxidation 1000°C 10h)

Beam time: 1.1×10^5 sec (32.5h)

Dose: 5.8×10^{19} e, 2.3 mdpa (for Fe E_d =40keV)

2nd specimen (ODS sp-10 pre oxidation 1000°C 10h)

Dose: 6.5×10^{19} e, 2.6 mdpa (for Fe E_d =40keV)

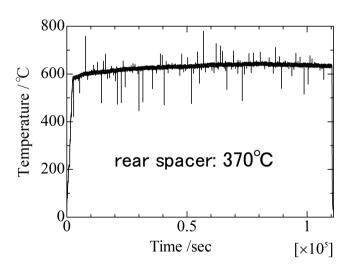
1st specimen

Temperature monitor was failed because of trouble on AD8495 thermo-couple amplifier.

Another attempt showed: pre-spacer 630°C, rear-spacer 430°C
